Our ref: EJM/CE/17226-01

4th April 2016

RE: THE BLAKE COTTAGE, FELPHAM, WEST SUSSEX

FOR THE MORTON PARTNERSHIP LIMITED,

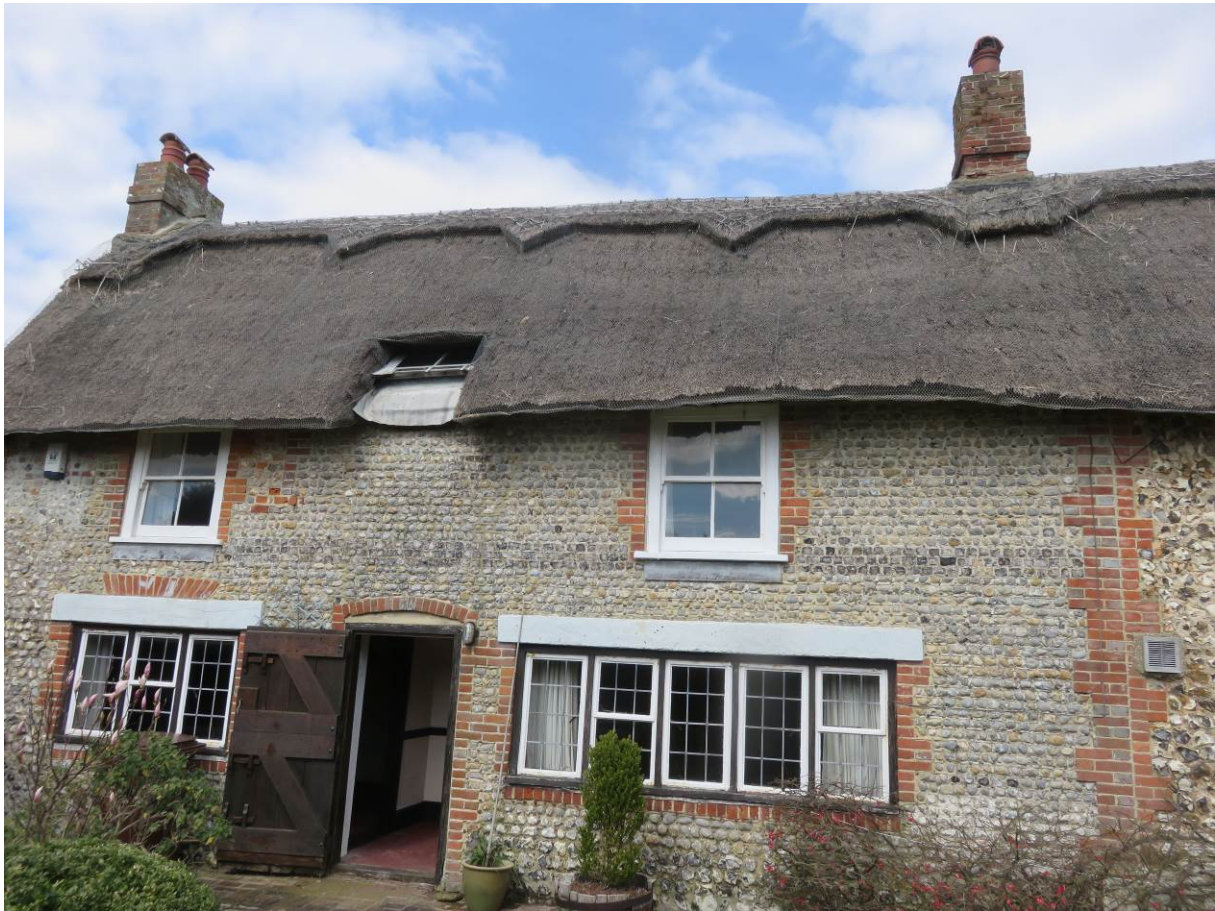
The area of defects relates to the original C1700 section of the Grade II* listed building where there is noticeable cracking to the ceiling at first floor level, mainly to the south side, as well as evidence of the front wall having been pushed out of plumb. I attach a brief cross section sketch of the house in this area showing an indication of the structural elements and how they relate. It should be noted that the eaves of the roof, to both elevations, is not directly tied by ceilings or floors, so there is always some potential for roof thrust to develop, although normally this will reach a natural equilibrium.

Photograph 1: South elevation of c. 1700's section

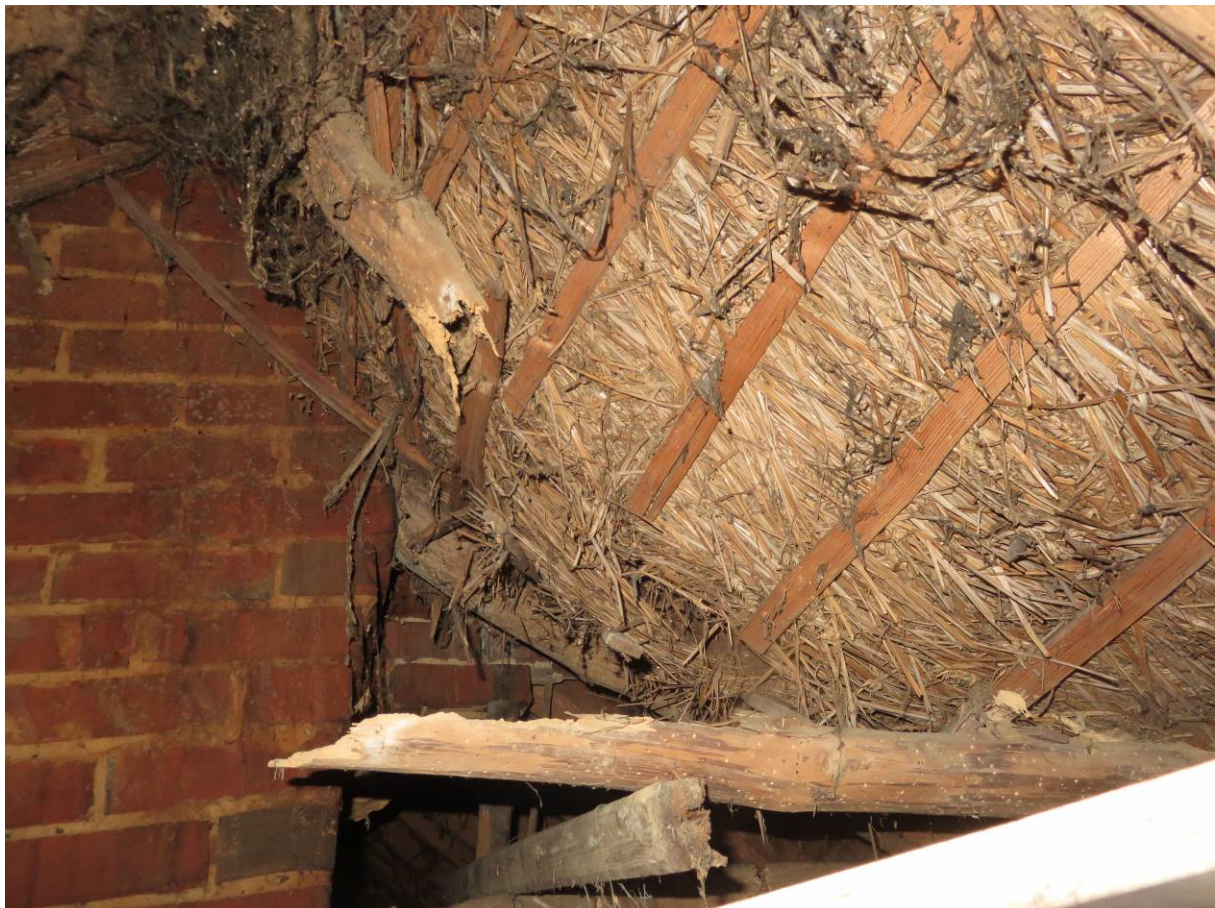
By peering into the access hatch to the upper roof void to this area, I was able to see that a number of the common rafters have snapped, and totalling at least 8 in number (see photographs 2 and 3). These are pole rafters, typical in this geographical area and for thatched roofs, and essentially comprising timber in the 'round' being the whole section of tree or branch and thus containing a high proportion of sapwood and a low proportion of heart wood. The sapwood is both a weaker material and also more prone to insect attack due to its relative softness and when green the higher moisture content. However you often find with pole rafter roofs that the thatch can work with these and create a partial diaphragm action.

Over time thatched roofs are often over laid and thus adding to the weight, or as they deteriorate they tend to hold more moisture again increasing the weight and thus make the rafters more susceptible to failure. The reason for the failure here, is not absolutely clear, but may be one or a combination the causes set out above.

Photograph 2: Failed rafter to east of hatch

However I do consider it appropriate and necessary to provide some temporary support to the structure until such time that the building is re-roofed and associated roof strengthening carried out. The sketch attached includes a temporary proposal, which is essentially to prop the roof structure, both at ridge level and then also just below the collar (ceiling joist position). It will be necessary to back prop at ground floor level onto the concrete slab, and depending on the positions of the upper supports this may be either to the floorboards direct or possibly to a pair of joists and as indicated on the sketch.

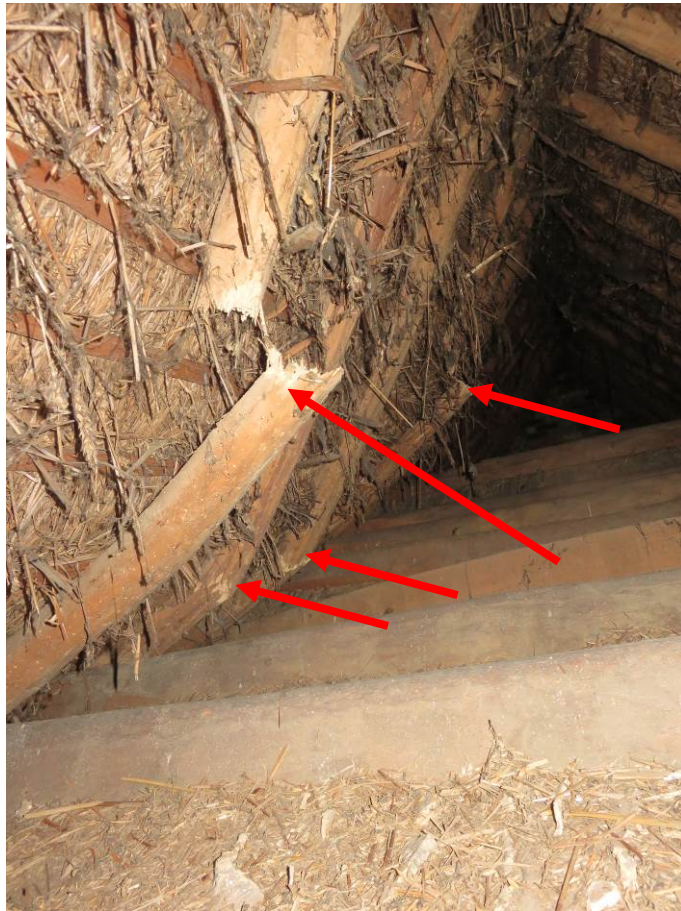
Photograph 3: Failed rafters to west of hatch

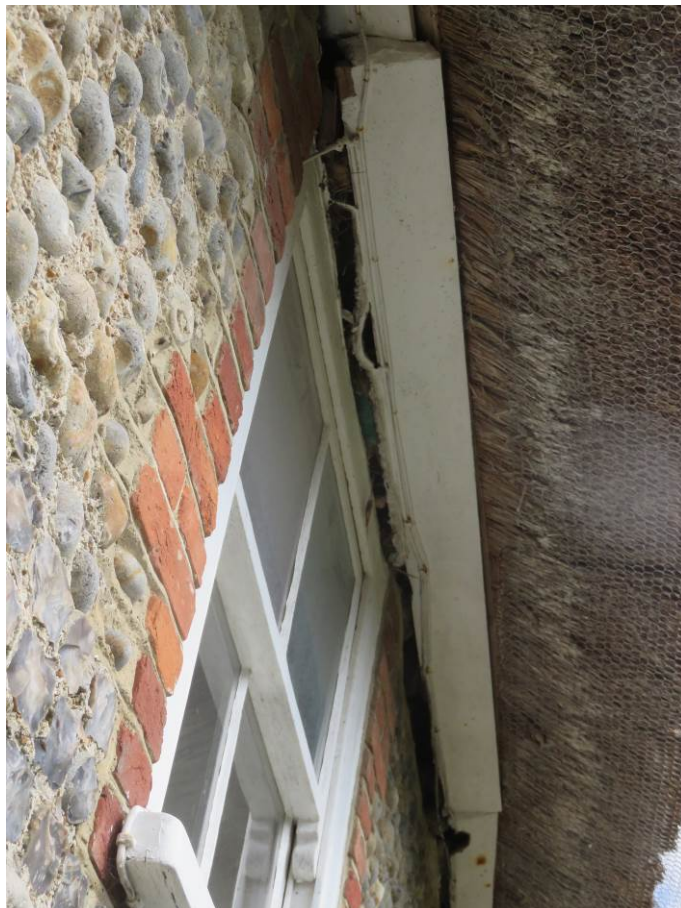
With the rafters failing, there has been a clear thrusting out of the roof, pushing on the wall so this now leans in its upper most section, however I do not consider this significant at this time. There is also movement evident to the front wall plate as seen from the underside of the soffit board (see photograph 4).

Photograph 4: Movement to front wall plate evident to soffit board

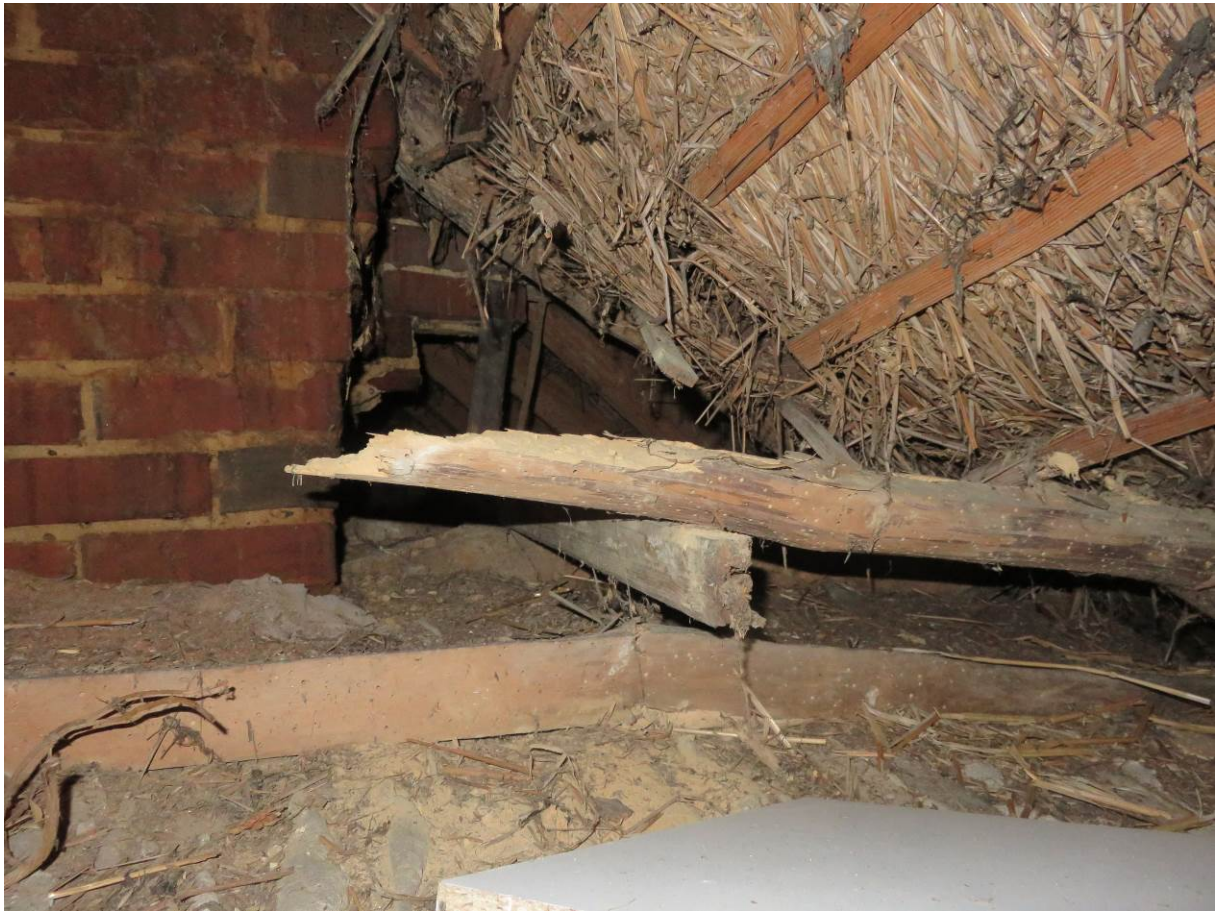
I did note to the east end of the roof that there is a small section of 'hanging' brickwork with a slightly tenuous supporting timber (see photograph 5). Full access or inspection was not possible, but this will clearly need to be attended to as part of the proposed works.

Photograph 5: Section of hanging brickwork seen in background

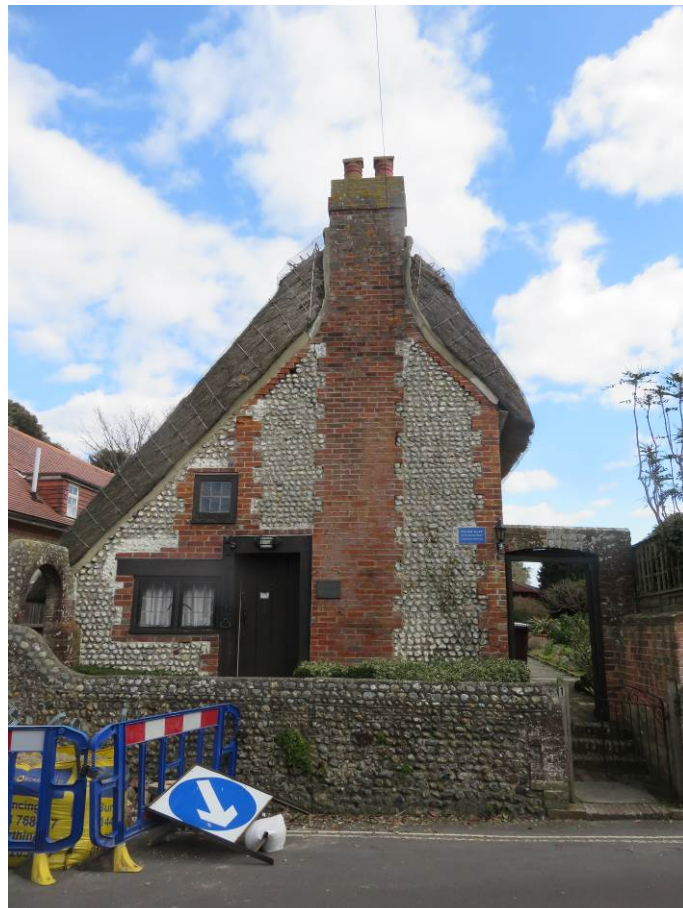
There was also movement to the west gable which was pointed out to me (see photographs 6 and 7). This is obvious particularly at the junction of the brick and flintwork, but also in the flintwork panels themselves. Some of this may relate to roof thrust to the south front elevation, and there may also have been some shrinkage of the new green oak frame to the inserted door or settlement following the adding of this and a re-distribution of the load. I do not suggest anything is necessary at this time, although pointing of the open joints would be beneficial to both help reduce water ingress, as well as then providing a reference to establish if the movement is progress in nature. If no work is carried out at this time, then visual monitoring at minimum should be carried out.

Photograph 6: West gable

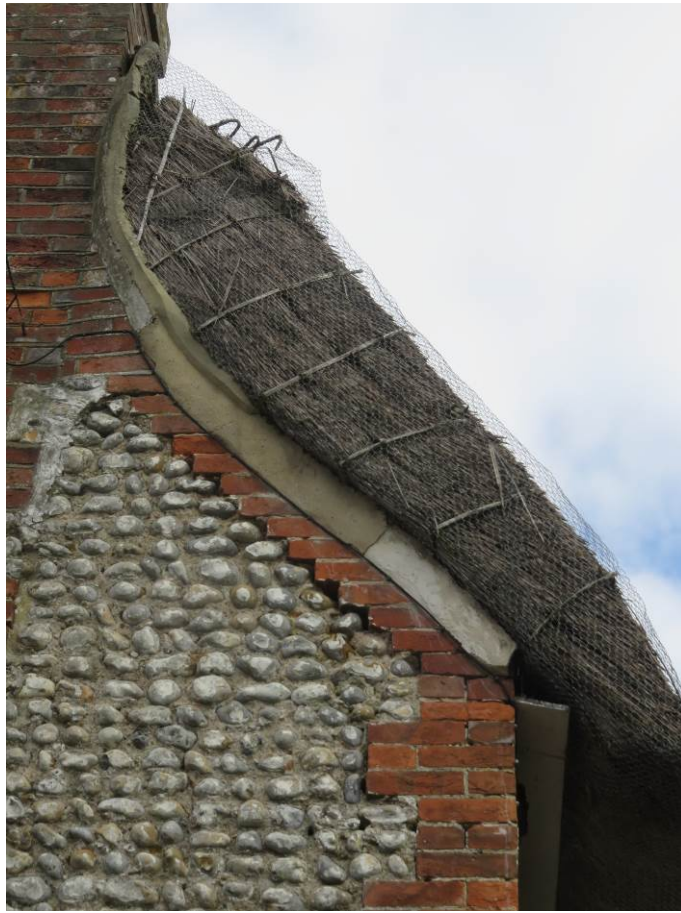
Photograph 7: Cracking seen to south side of west gable on underside brick verge and in flintwork
